DOT/FAA/RD-93/2

## Rooftop Emergency Heliports

June 1993

Final Report

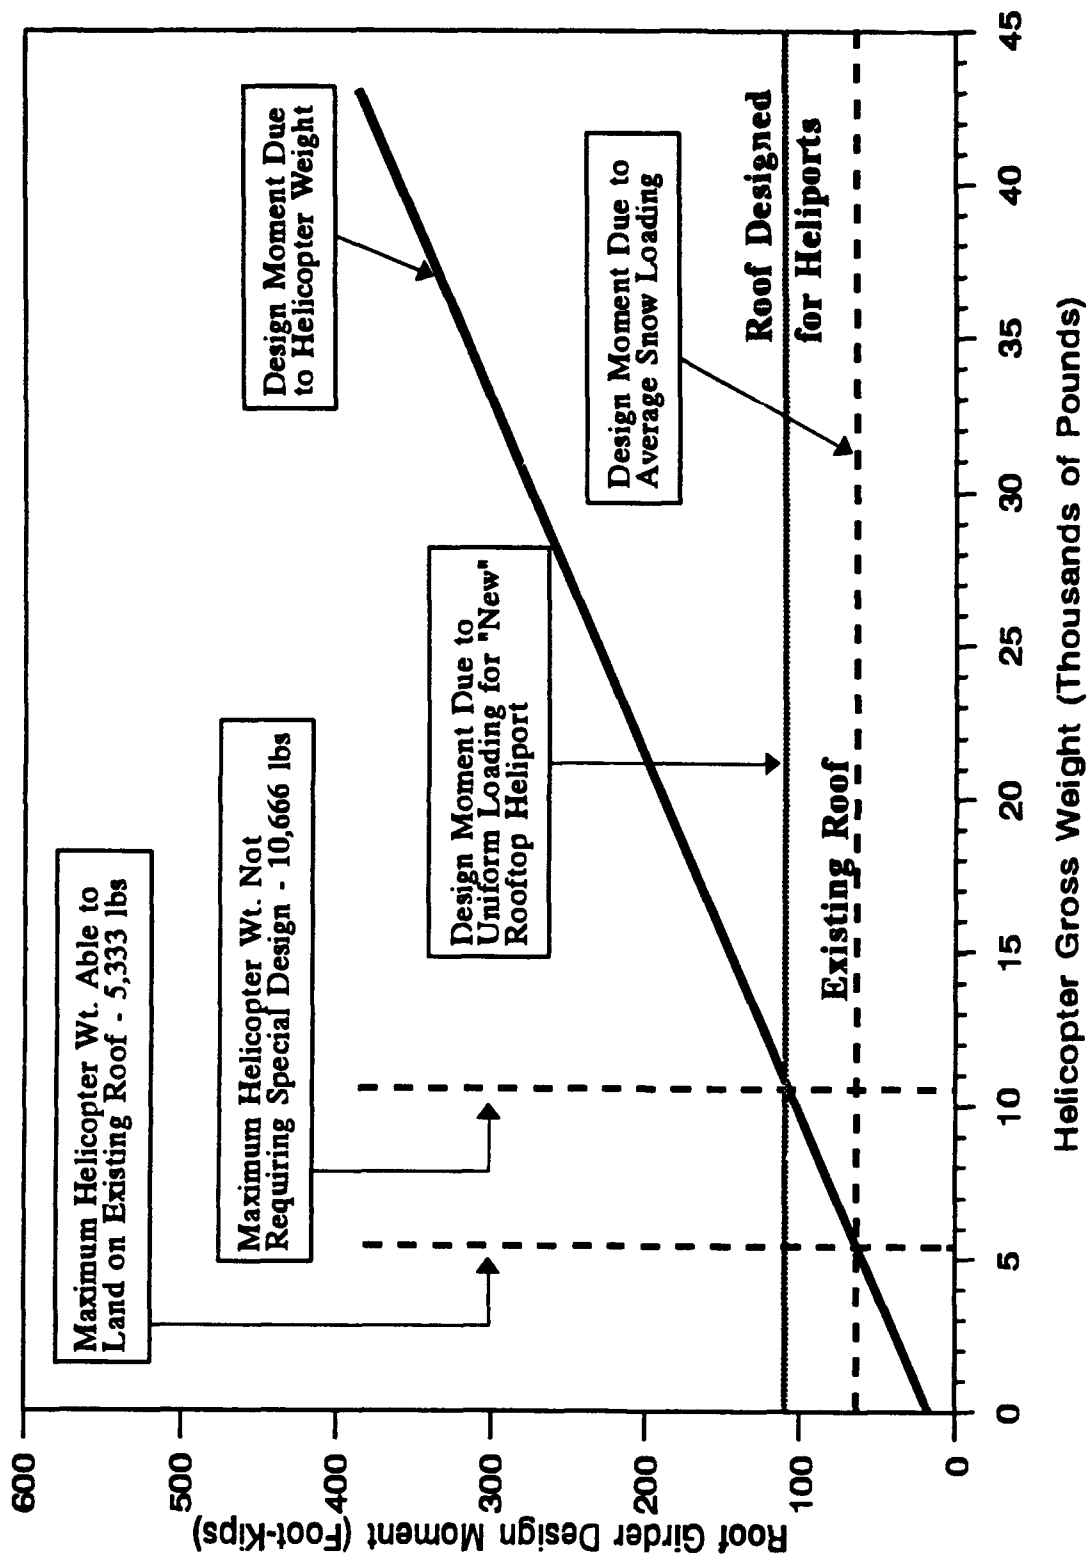
**FIGURE 1 UNIFORM BUILDING CODE, 1991 - CASE 1: 20' X 20' BAY SPACING WITH 20 PSF DEAD LOAD**

The results from figures 1 through 6 indicate that the NBC produces the greatest girder design moment. For this analysis the NBC produces the most rigid minimum design standard, followed by the UBC and the SBC. This is the case for both column spacings. Table 4 shows that the minimum design requirements spelled out in each code will result in the design of a main structural system (i.e., girders, columns, and foundations) to carry up to the "maximum helicopter weights" listed. Helicopters exceeding the listed weights would then require analysis using loading condition numbers 1 and 2.

Graphic representations of the results of the analysis are depicted in figures 1 through 6, showing the relationship between the three loading conditions for each of the three codes, and for both 20-foot and 30-foot column spacings, case 1 and case 2 respectively.

This would be a typical controlling loading condition for a standard (non-heliport) roof designed per the building codes and is indicated in the figures as a fourth loading condition. The design moment caused by this loading is represented by a horizontal dashed line in the figures and is labeled "existing roof."

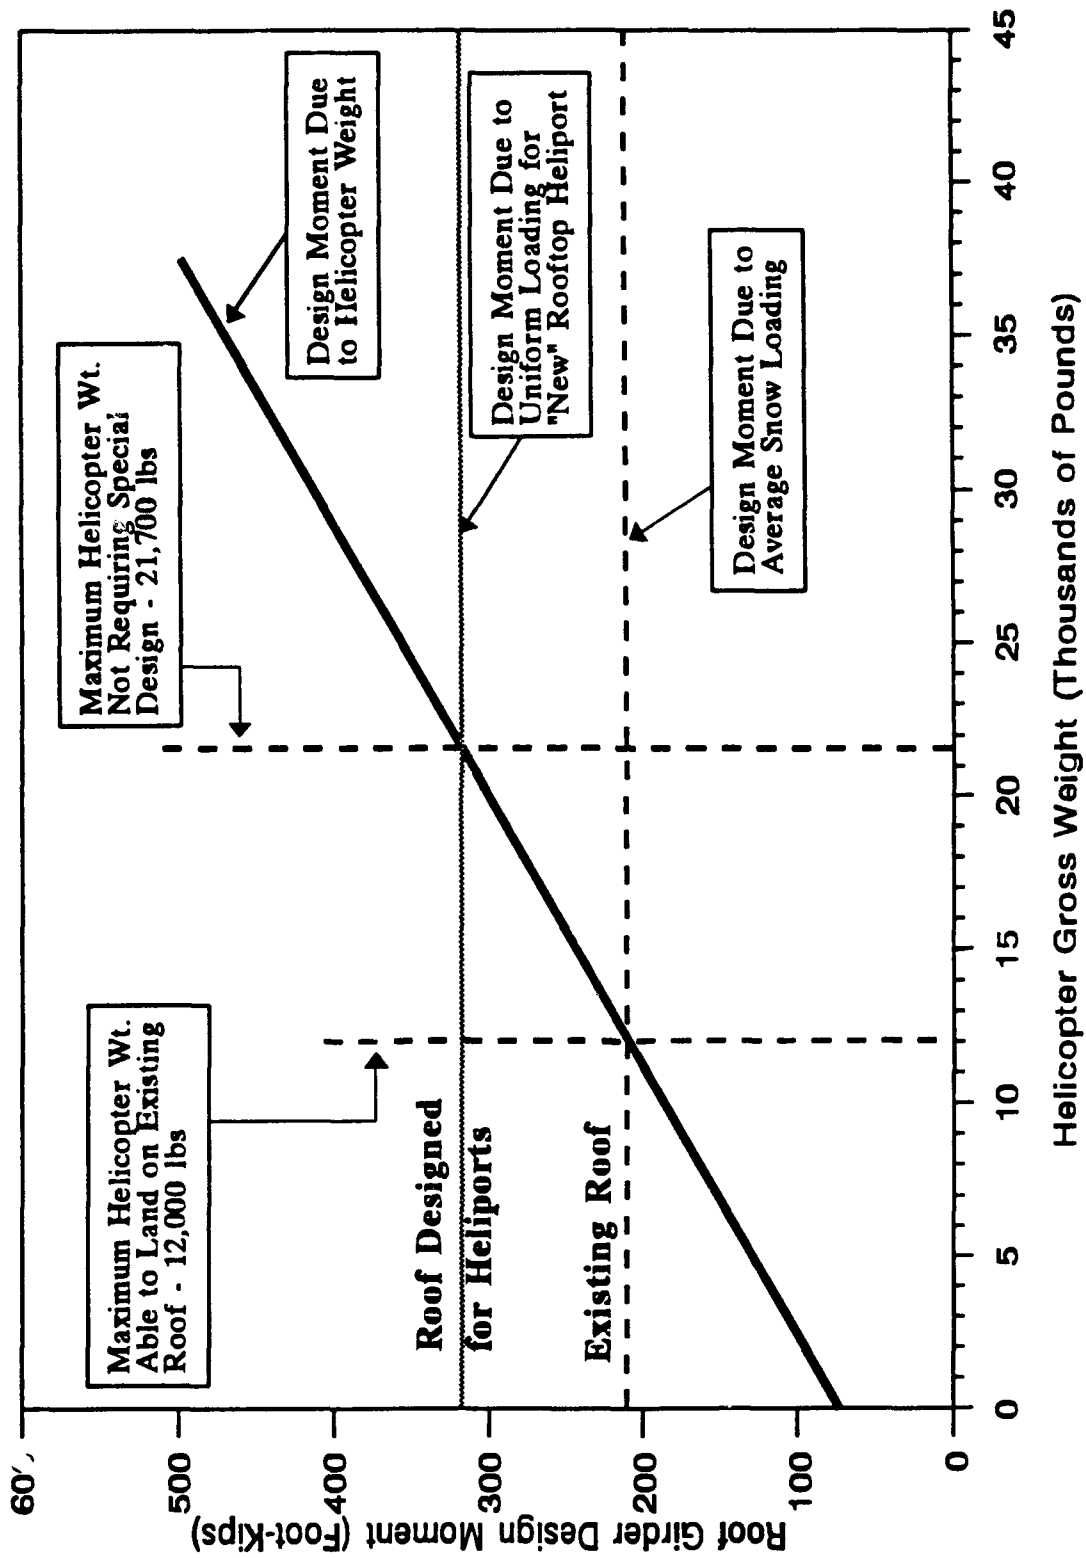
FIGURE 2 UNIFORM BUILDING CODE, 1991 - CASE 2: 30' X 30' BAY SPACING  
WITH 20 PSF DEAD LOAD

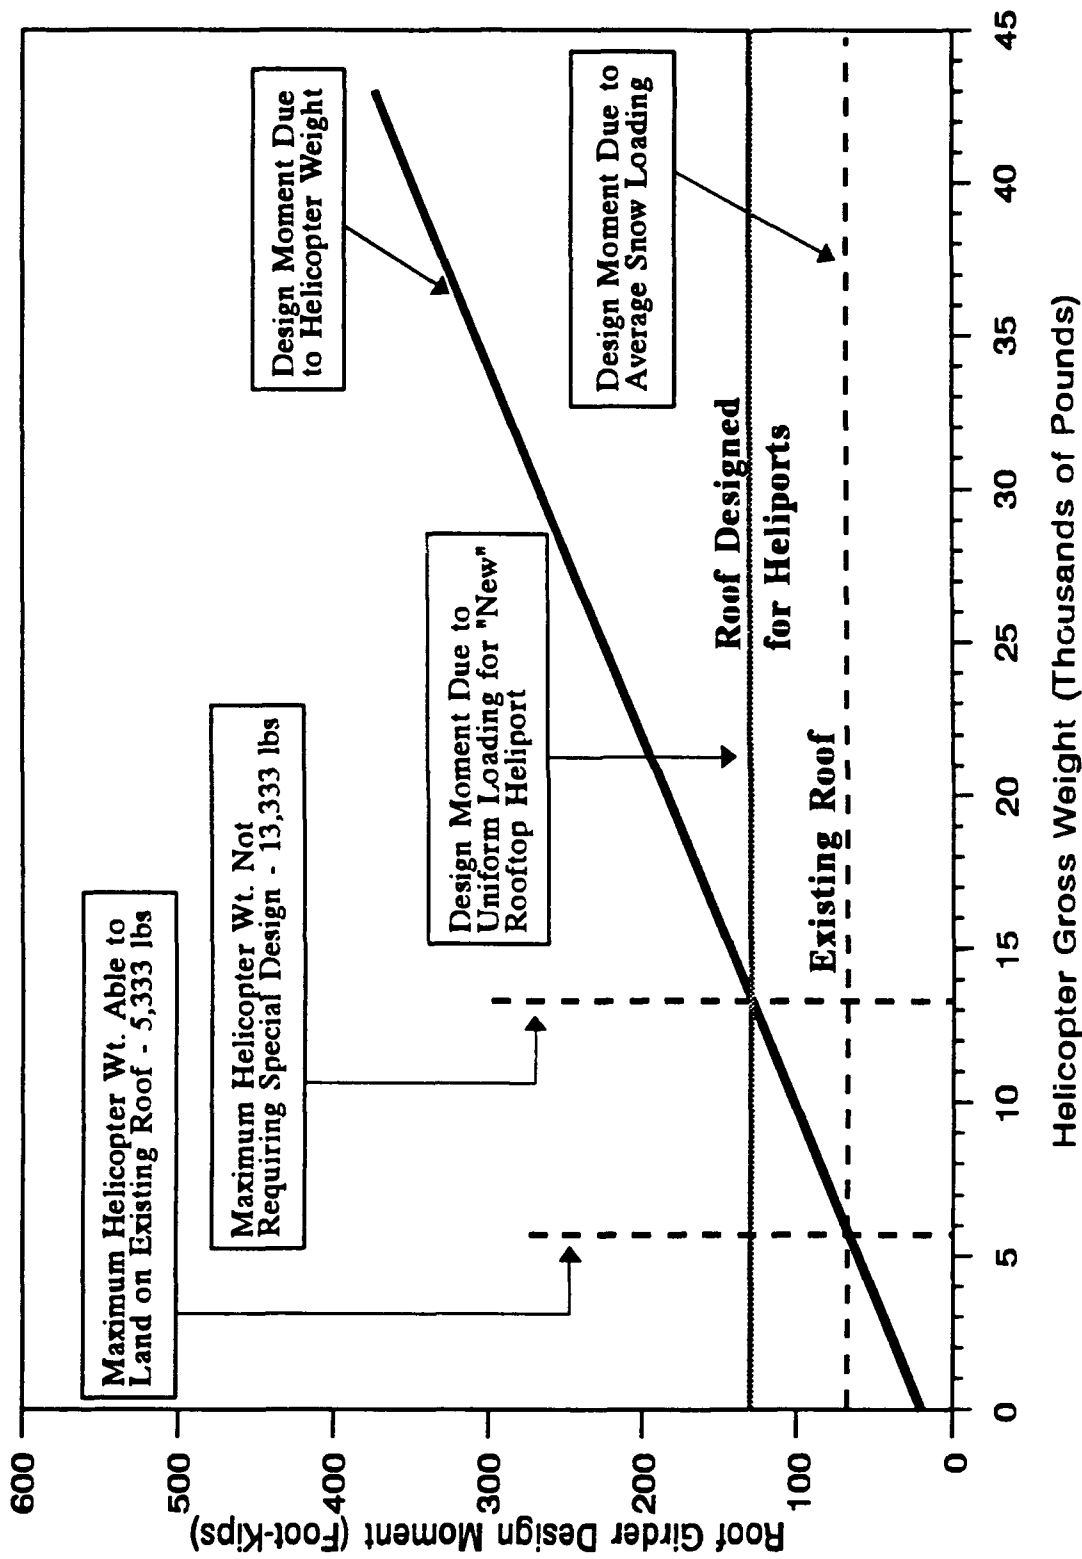
FIGURE 3 NATIONAL BUILDING CODE, 1991 - CASE 1: 20' X 20' BAY SPACING WITH 20 PSF DEAD LOAD

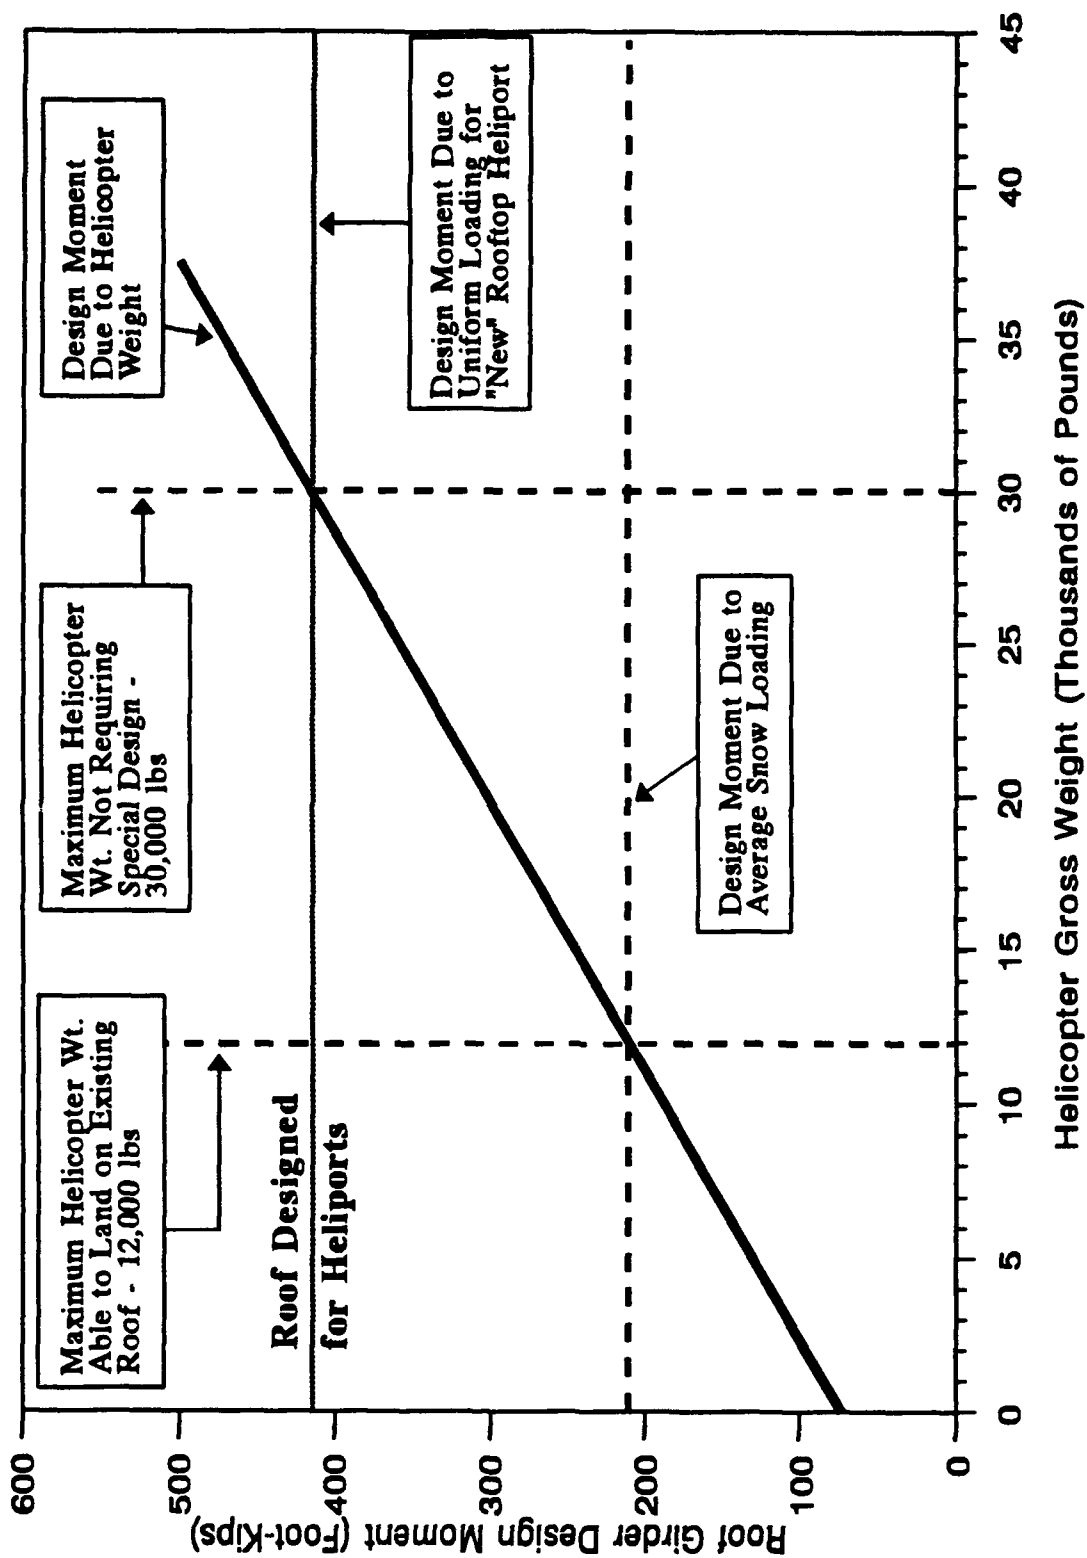
**FIGURE 4 NATIONAL BUILDING CODE, 1991 - CASE 2: 30' X 30' BAY SPACING WITH 20 PSF DEAD LOAD**

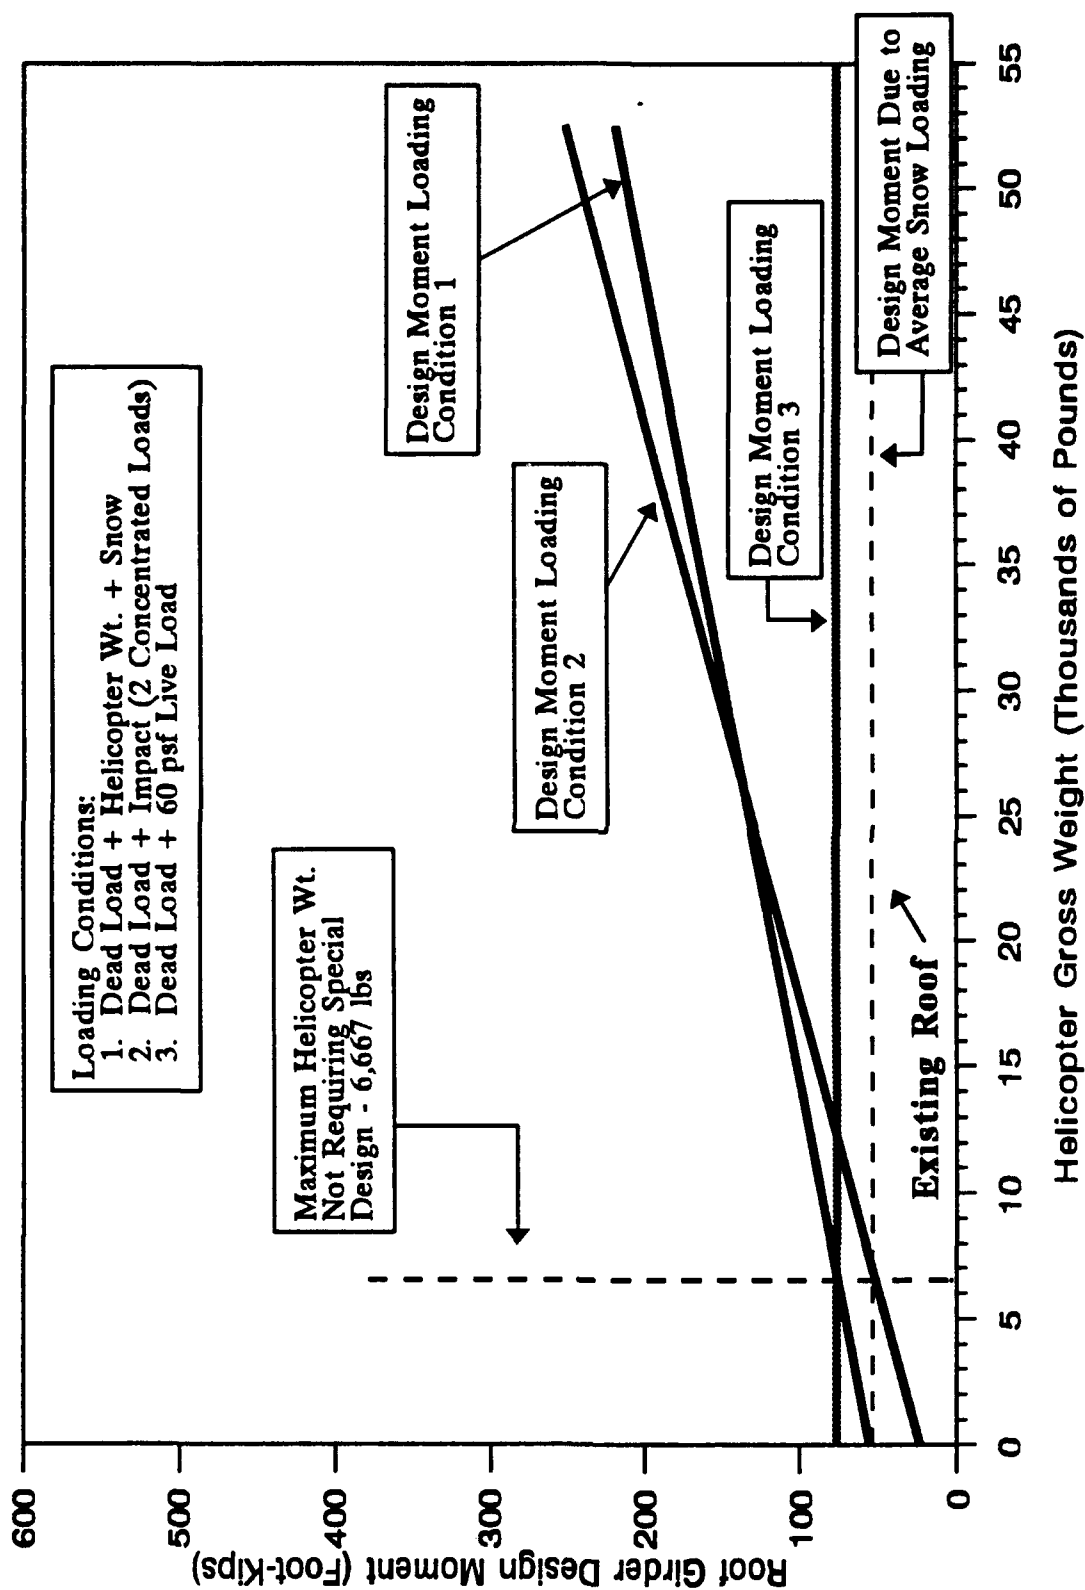
**FIGURE 5 STANDARD BUILDING CODE, 1991 - CASE 1: 20' X 20' BAY SPACING WITH 20 PSF DEAD LOAD**

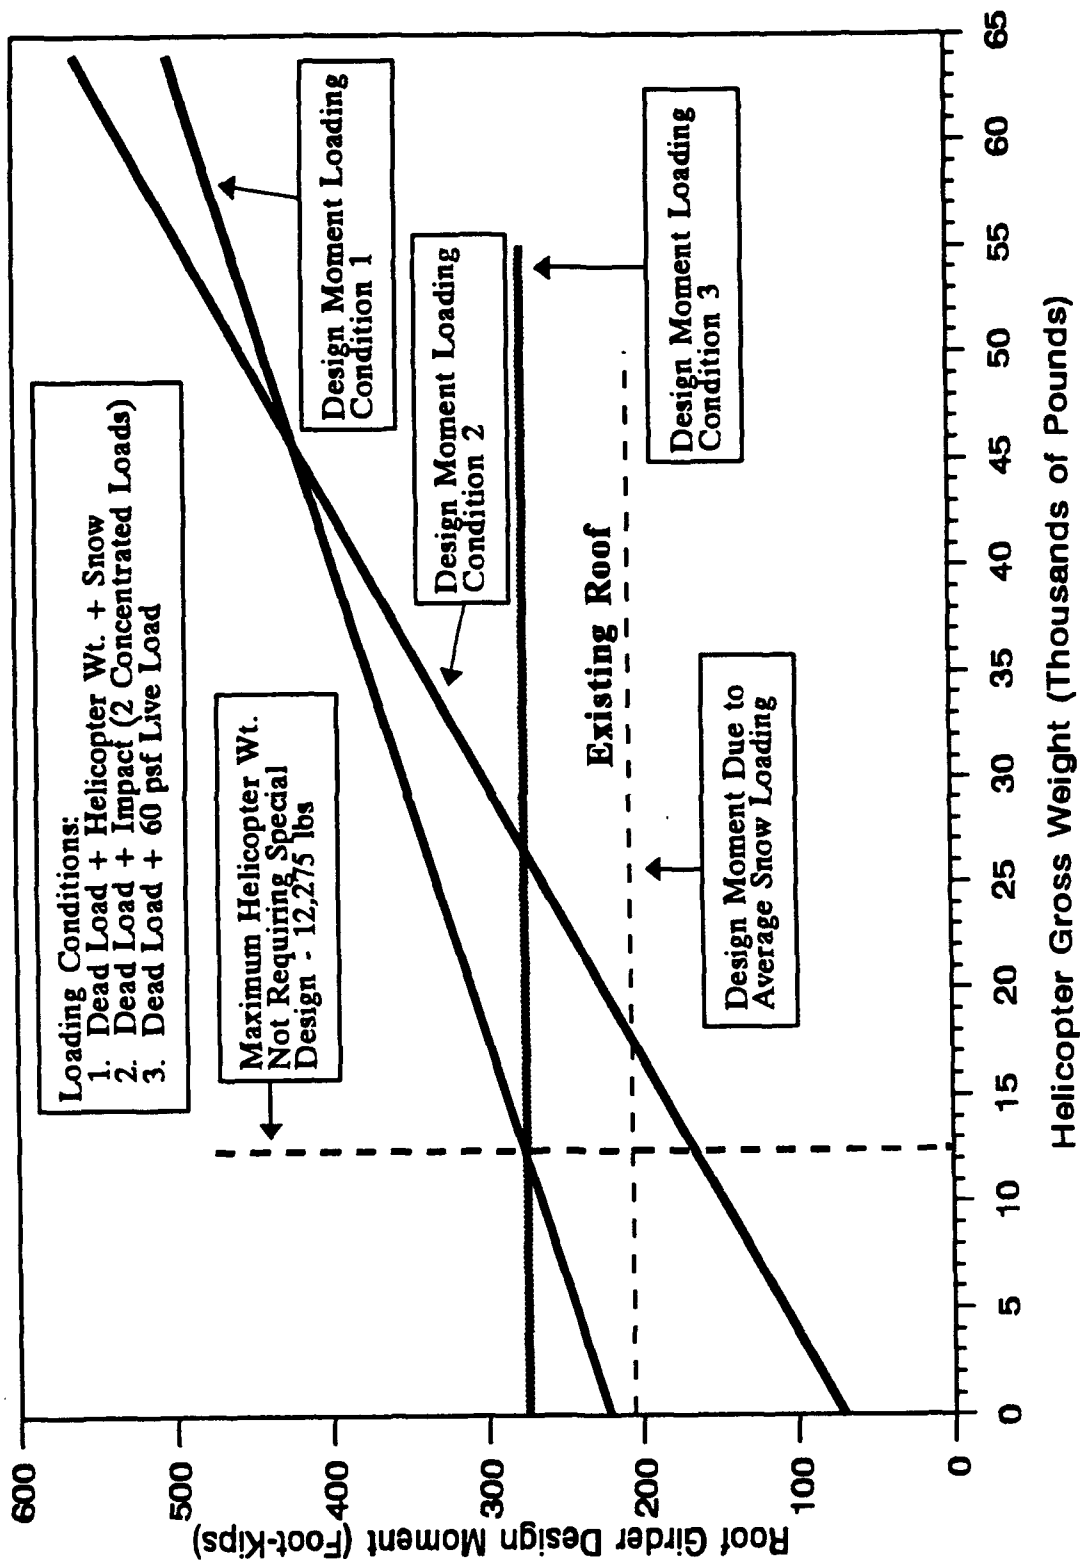
**FIGURE 6 STANDARD BUILDING CODE, 1991 - CASE 2: 30' X 30' BAY SPACING WITH 20 PSF DEAD LOAD**
